vector

Runway Excursions

The Language Barrier

Managing Volcanic Ash

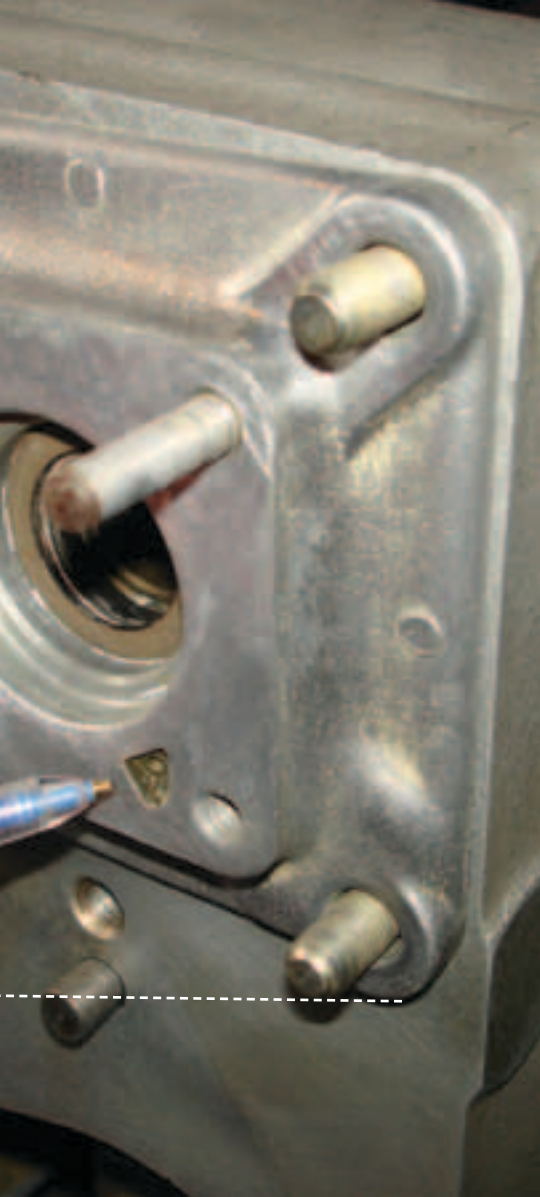
The dry vacuum pump effectively blanks

an oil pressure port that provides lubrication to an oil-lubricated vacuum pump, on certain aircraft. These are known as 'wet' pumps. The differences would be obvious to any appropriately rated Licensed Aircraft Maintenance Engineer (LAME). By removing the 'dry' pump, the owner had left the oil free to exit the engine at speed. Had a LAME removed the pump, they would have immediately installed a blank to the 'wet' pump port to keep the oil where it needed to be.

Recently, a light aircraft owner decided to save a bit on maintenance by removing a vacuum pump after it failed in flight, causing the Artificial Horizon (AH) to wander. The owner booked the aircraft in for maintenance, confident that he could legally fly it to the maintenance base without an AH on a private VFR flight.

He took off, raised the flaps and then adjusted the power setting. Immediately he noted the prop rpm response was not normal and the engine sounded noisy. He decided to carry out an emergency landing onto a nearby airfield. It was a wise choice.
