# **Continuing Airworthiness Notice – 27-027**

## **Guimbal Cabri G2 Main Rotor Swashplate Assembly Cracking**

08 Feb 24

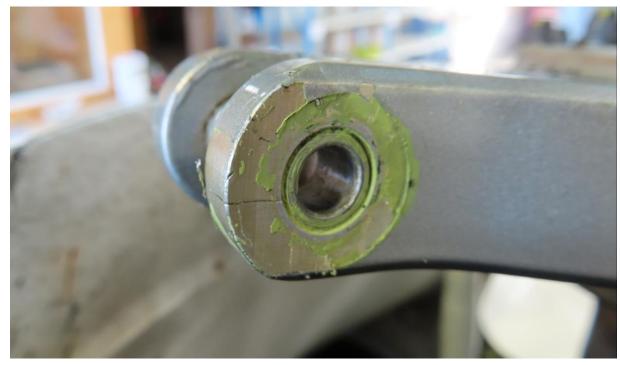
The CAA have received a report from a New Zealand operator of a Guimbal Cabri G2 of finding cracks in the rotating swashplate pitch link attachment clevis arms. Two of the three clevis arms were affected, with crack indications in one side of each affected clevis arm (see picture below).

Note - One of the cracks reported was only detectable after paint removal. If paint removal is undertaken, care must be taken to ensure that no damage is caused to the swashplate.

In response to this finding, Guimbal have released mandatory Service Bulletin SB24-001A which identifies an initial and recurrent inspection schedule for the swashplate.

The CAA recommends that aircraft operators comply with Guimbal Service Bulletin SB24-001A.
