vector

Situational Awareness

Review of Airworthiness

SMS Update

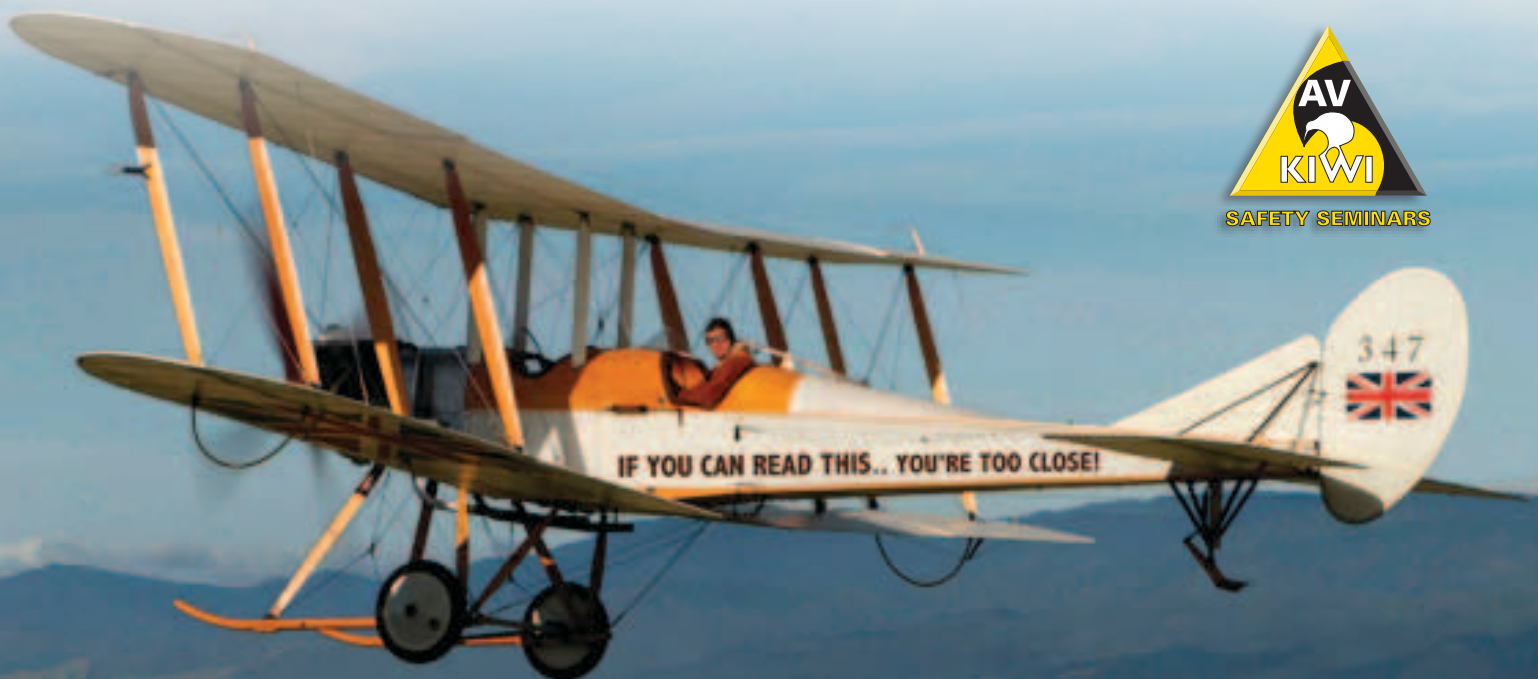
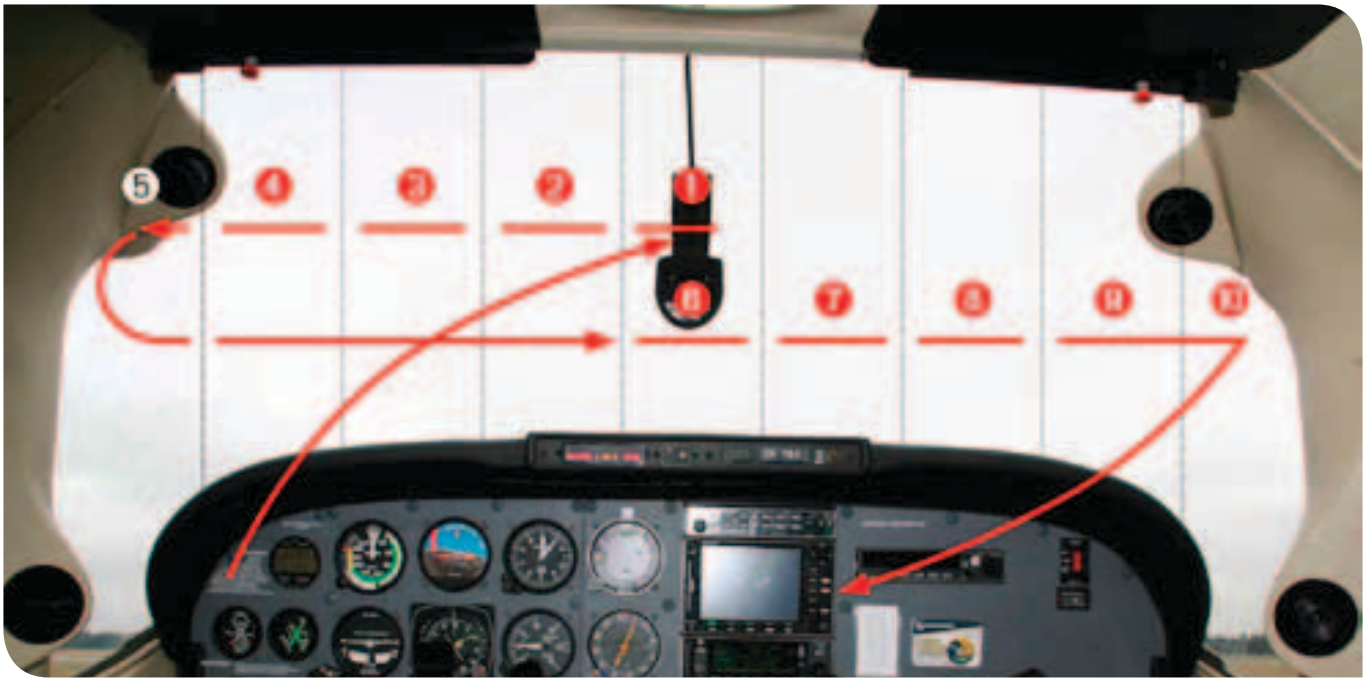
One method is to start your scan in the centre, moving progressively to the left, pausing for two seconds every 20 degrees. Then swing quickly back to the centre and continue your scan to the right.

There are many scanning techniques - this is one example. Use a method that suits you, but make sure it includes pausing to focus in each zone, and continues round the sides as far as you can see.

If scanning before turning the aircraft, do your scan so that it ends in the direction of the turn. The illustration doesn't show the scan reaching right around to the sides, but this is essential, as the following example illustrates.

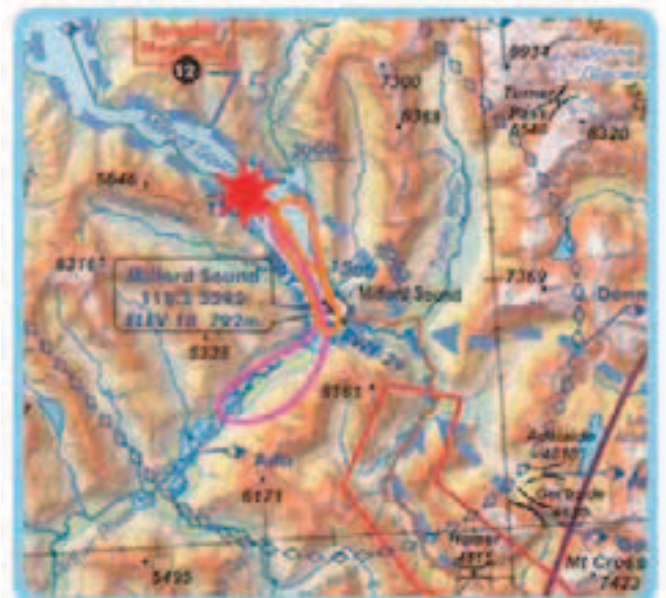
This shows the tracks of DAX and DQF before and up to the Milford Sound accident.

Subsequently, DAX and DQF paralleled each other's track for about 90 seconds. Neither pilot saw the other aircraft. A passenger in DAX filmed DQF as it flew alongside, but failed to alert the pilot to the close proximity of the two aircraft. English was not the first language of the passengers on board DAX and DQF.

The two aircraft collided – the pilot of DAX managed to fly the damaged aircraft back to Milford and land safely, but DQF crashed into Milford Sound. The wreckage was never recovered.

A safety investigation identified that causal factors included the pilots' restricted cockpit vision, the lack of an effective lookout, the high density of traffic, and the unplanned merging of two streams of aircraft.

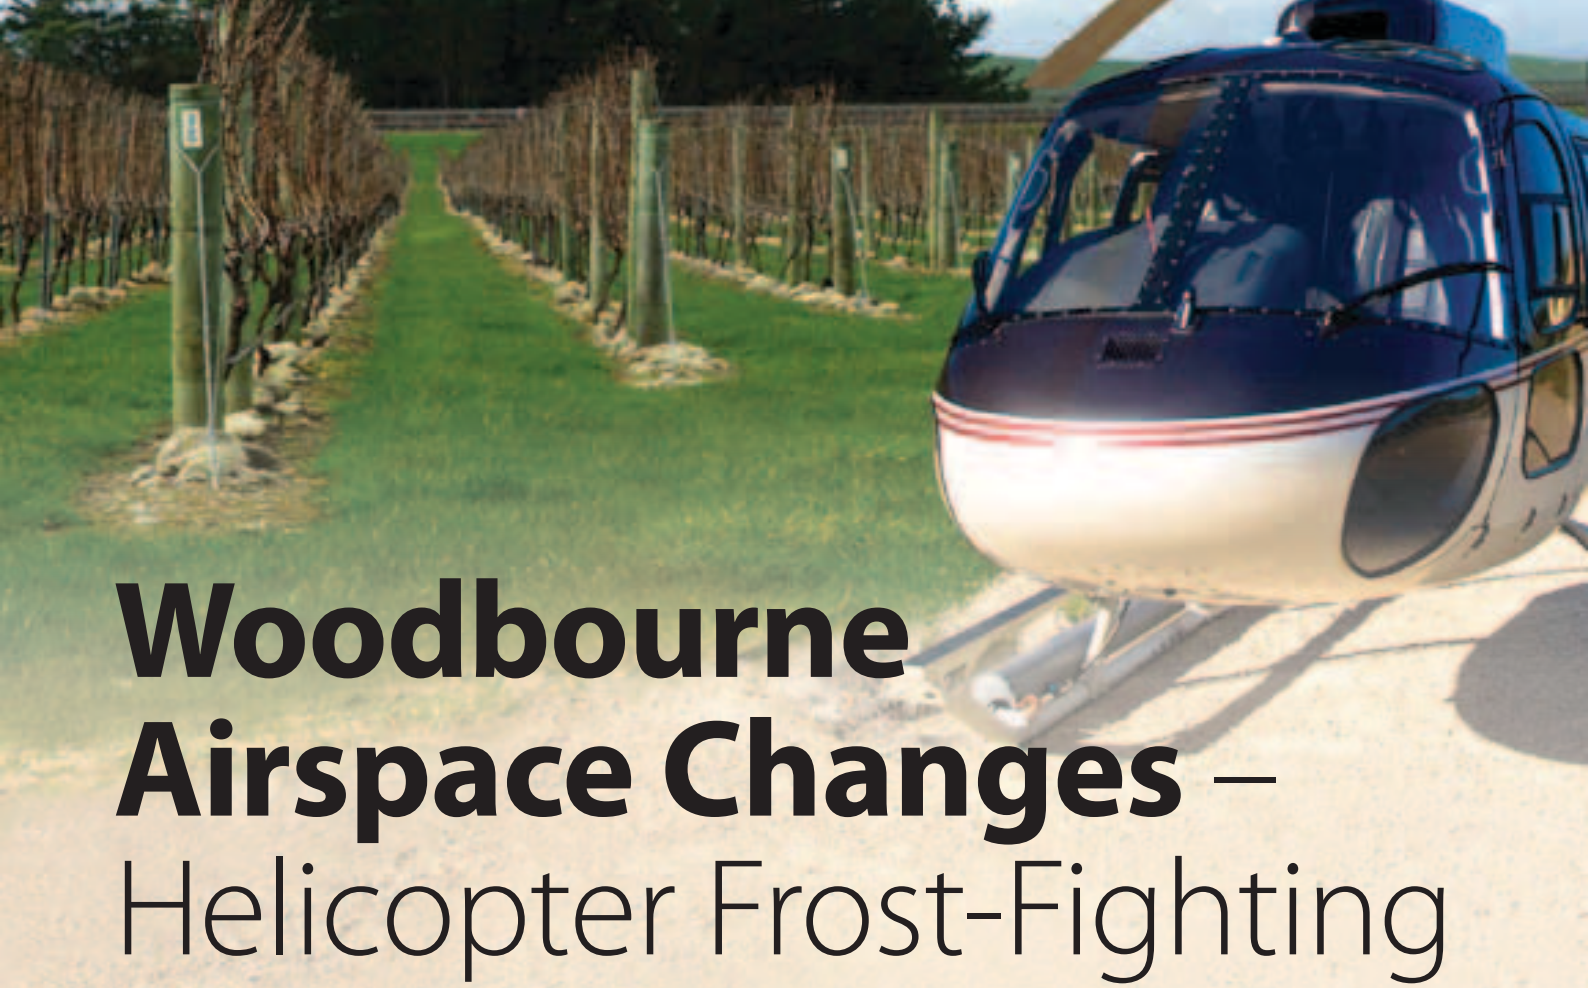
Woodbourne Airspace Changes – Helicopter Frost-Fighting

Temporary Woodbourne airspace will be activated as required to accommodate frost-fighting helicopter operations in the local area. The changes will also have implications for IFR operators.

This year, when the temporary airspace is activated, the CTR is disestablished and replaced by a much-reduced version. This is basically the present Instrument Sector with shortened outer ends.

The replacement CTR extends from the surface to 1500 feet, and has a surrounding control area (CTA) from 1000 to 1500 feet. This arrangement is then capped by a new CTA from 1500 to 3500 feet.
