BIRD STRIKE!

Experienced pilot Phil Welcome got the fright of his life when he took off in his Piper PA-31 Navajo from Whitianga aerodrome in March and met with a “river of brown”.

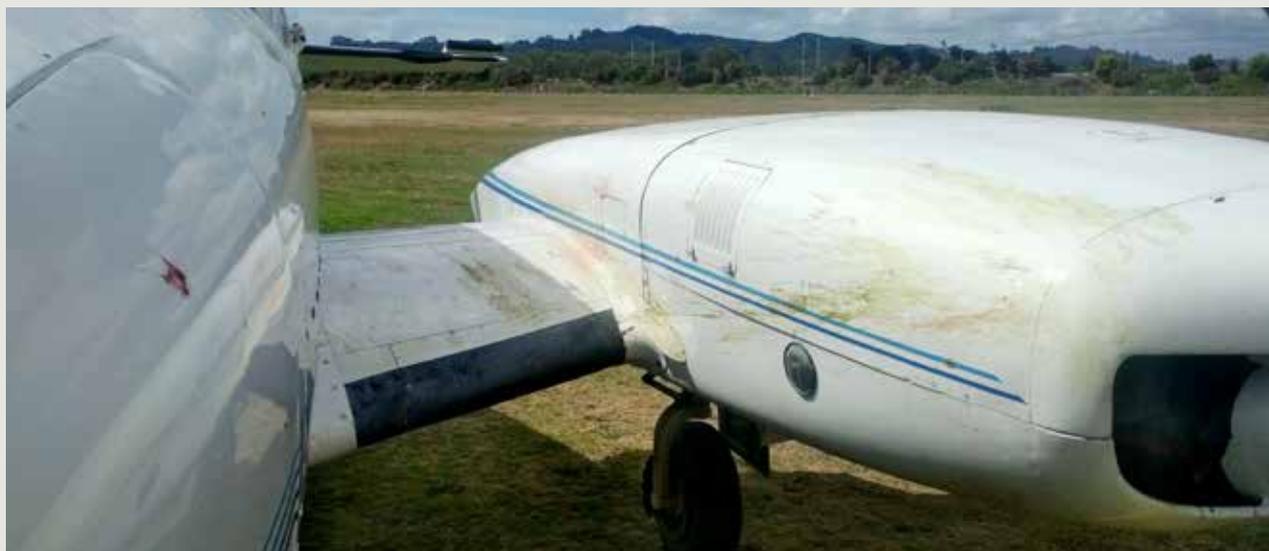
// The left engine took a bruising. Photo supplied by Phil Welcome.

“I began to remove bird parts from the engine cowling and undercarriage legs. The look and smell was awful. Bits of dead bird were getting baked onto some of the cylinder fins and I was concerned about engine cooling. Shortly after, a friend came down with a hose and a power washer to help clean the aircraft.”
