BATTERIES – FOLLOW MANUFACTURER INSTRUCTIONS!

The era of electric aircraft is upon us. Operators *must* follow manufacturer instructions to minimise the risk of battery fires that could end in tragedy.

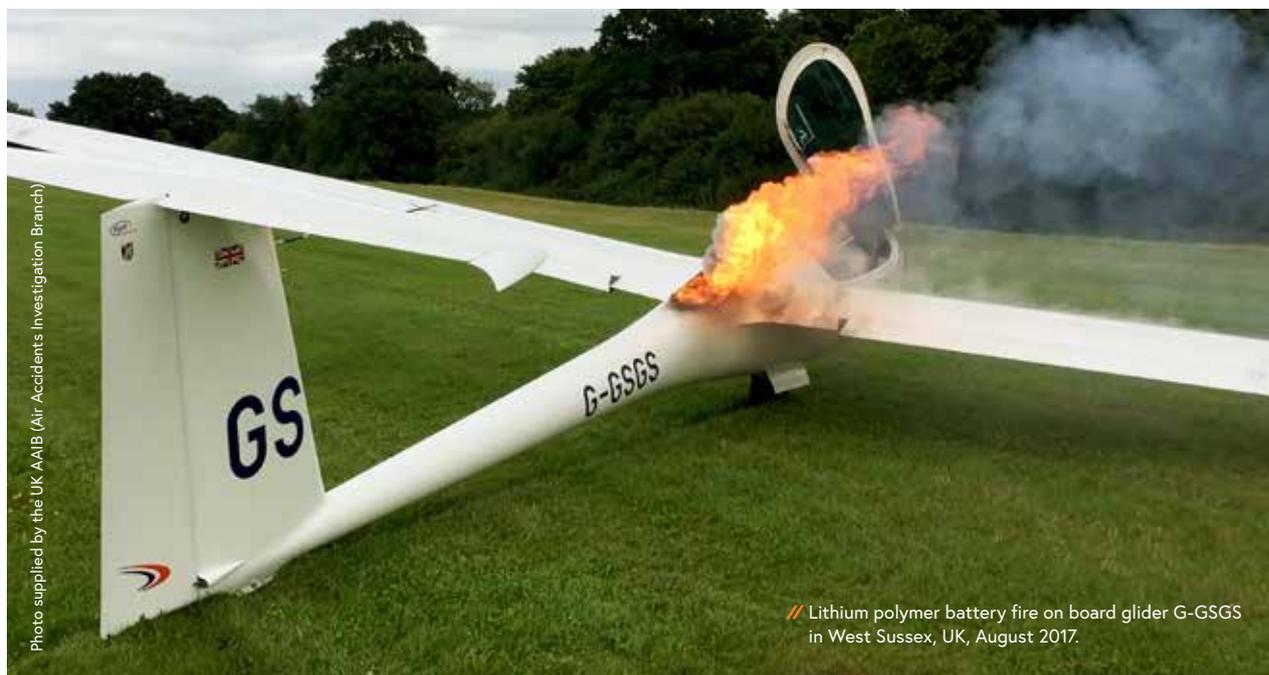
// Lithium polymer battery fire on board glider G-GSGS in West Sussex, UK, August 2017.

// If a battery-related event occurs in flight it can be the smoke that's the danger – even without any fire present. //
